SUBJ: RCRA Compliance Evaluation Inspection  
Southern Wood Treatment Co.

EPA I.D. Number: KYD 076 769 728

## RCRA Compliance Inspection Report

Southern Wood Treatment Co. (Southern Wood)  
P.O. Box Gawthorpe Dr.  
Winchester, KY 40391  
EPA I.D. No.: KYD 076 769 728

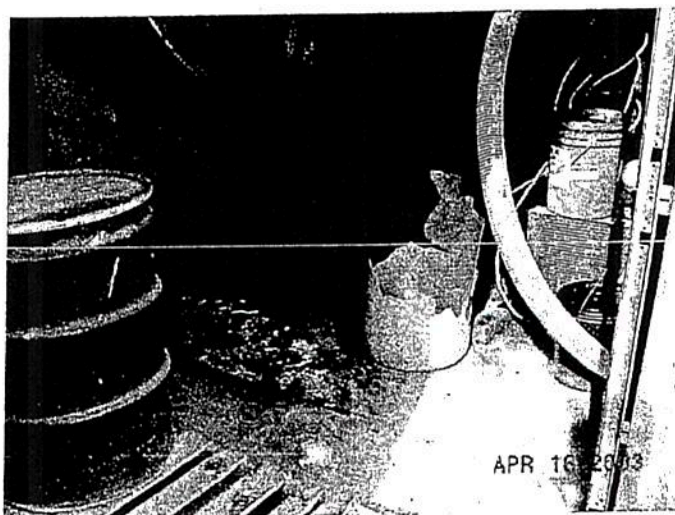
Upon entering the CCA treatment area which consisted of a large metal building and concrete flooring, inspectors observed the large pressure cylinder on the right side of the facility and three large CCA storage tanks on the left side. Housekeeping at the facility was poorly managed. At the time of inspection, CCA mixed with rainwater had pooled on the floor throughout the facility (Photo 1).

401 KAR 34:030, Section 2 as incorporated by 401 KAR 32:030, Section 5 (1)(d) and 40 CFR § 265.31 as referenced by 40 CFR § 262.34(a)(4) require that facilities must be maintained and operated to minimize the possibility of a fire, explosion, or any unplanned sudden or nonsudden release of hazardous waste or hazardous waste constituents to air, soil or surface water which could threaten human health or the environment.

Photo 1. Pooled CCA/water mix on floor of process building.

Lloyd Funkhouser of KYDEP performed a follow-up visit to the facility approximately one week after the initial inspection. The facility corrected the violation by pumping the pooled mixture back into the holding tanks for reuse.

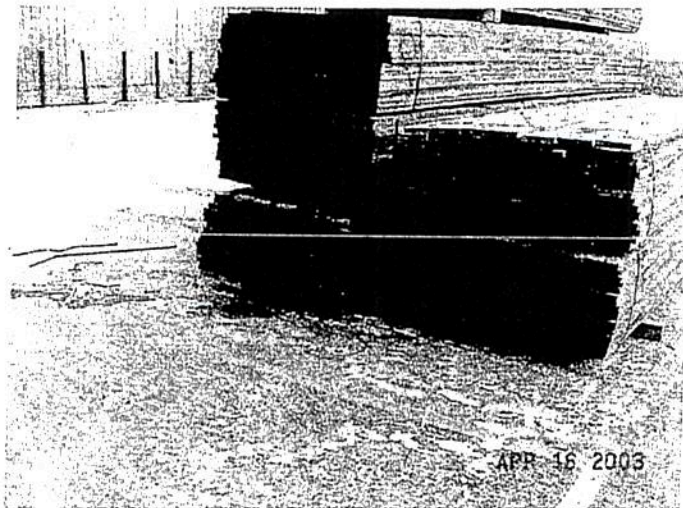
After leaving the pressurized cylinder, CCA treated lumber is moved to a drip pad located directly to the right of the process building (Photo 2). The pad is distinguished from unsealed concrete area by yellow "containment" lines and is equipped with an associated collection system (Photo 3). At the time of inspection, three pallets of treated wood were drying on the drip pad. Near the pad drainage system was an open box of CCA- treated wood chips, shavings, and debris (Photo 4). These shavings and debris are classified as D004/D007 hazardous wastes. Pursuant to 401 KAR 32:030, section 5(a)(1), hazardous waste is required to be placed in a container conforming to the regulation requirements in this subpart.

401 KAR 32:030, Section 5(a)(1) and 40 CFR § 262.34(a)(1)(i) allow that a generator may accumulate hazardous waste on-site for 90 days or less without a permit or without having interim status provided that the waste is placed in containers and the generator complies with the applicable requirements of 401 KAR 35:180, 35:275, 35:280, and 35:281. Southern Wood has failed to adhere to a condition for exemption from RCRA § 3005 and as such is illegally storing hazardous waste.

**Photo 2.** Drip pad distinguished from unsealed concrete area by yellow "containment" lines.

A follow-up inspection by Lloyd Funkhouser revealed that this violation was corrected by the facility. Waste CCA treated wood chips and shavings had been transferred to a 55-gallon drum.

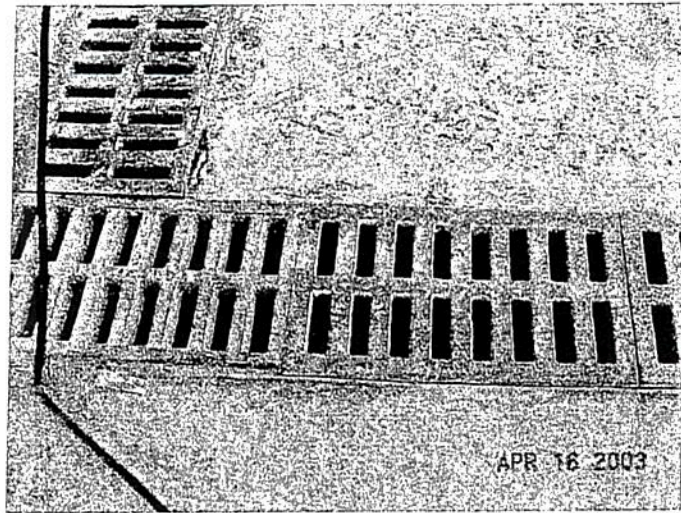
**Photo 3.** Run-off collection system located in the pooling area of the drip pad.

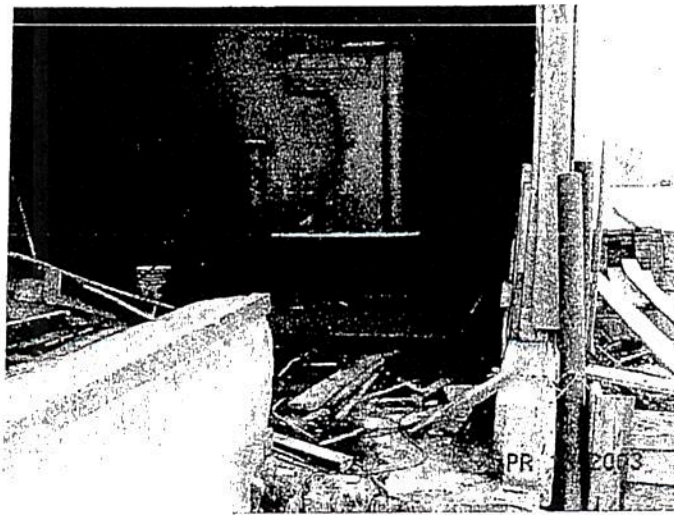
**Photo 4.** CCA treatment cylinder and waste pile (right).

After inspecting the CCA process area, inspectors walked the length of the property to the lumber unloading zone. Trash and debris were found scattered throughout the property (Photo 4). The same finding occurred behind the Dricon® facility where inspectors encountered a large mound of trash and debris (Photo 5). Although no EPA RCRA violations were attached to the findings, inspectors suggested the facility perform basic housekeeping tasks to avoid operating an open dump.

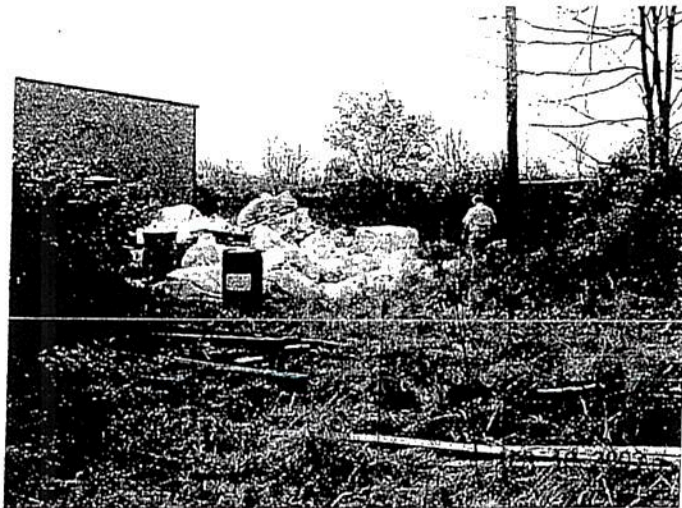
**Photo 5.** Trash pile located behind Dricon® process area on far right side of facility.
